## RIGHT-ANGLE FIRE WATER PUMP GEARBOX

### 2 PREAMBLE / PROBLEM REPORTED

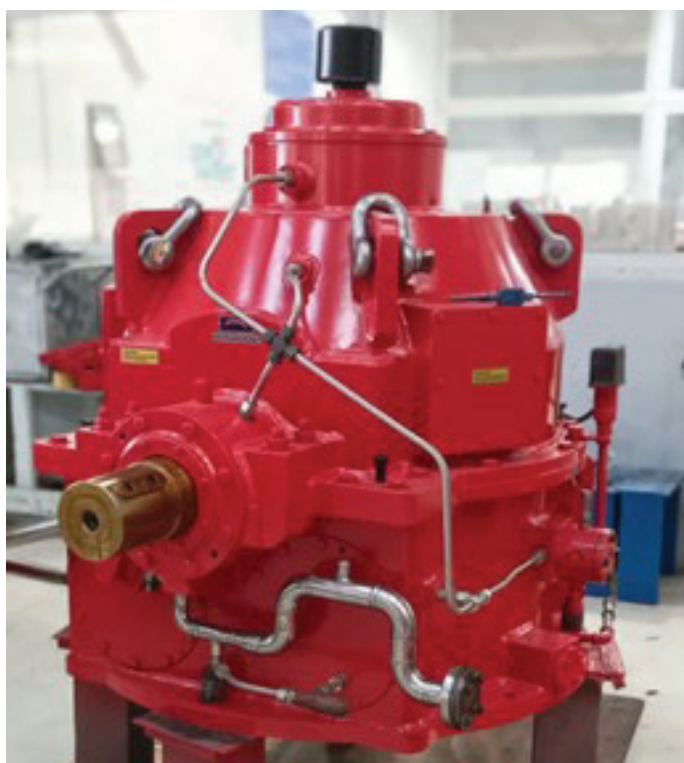
Newly supplied spare engine had a reverse direction of rotation (DOR), making it incompatible with the existing gearbox and fire water pump system. The customer approached Triveni PTB to modify the existing gearbox to accommodate the reverse DOR, while maintaining all existing boundary conditions and installation constraints.

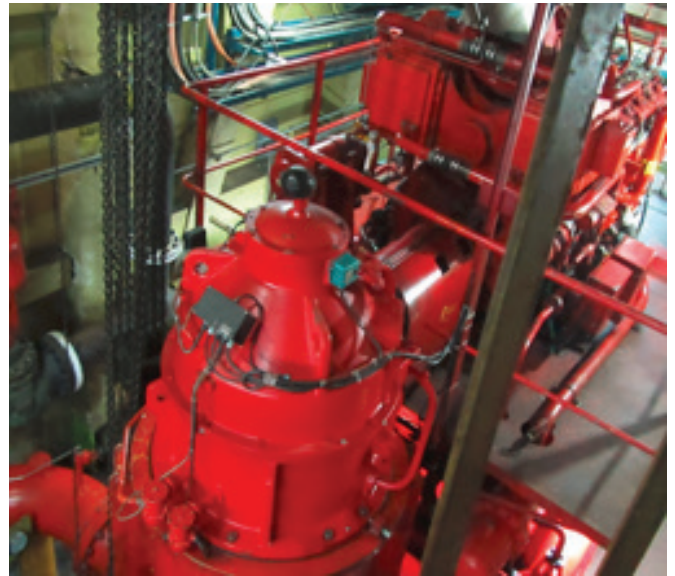
- All critical boundary conditions were thoroughly reviewed to ensure alignment with customer requirements
- Conceptual design analysis indicated that the output bevel gear arrangement required repositioning to achieve the desired change in rotation
- It was determined that relocating the bevel gear from the top to the bottom position would enable reversal of rotation direction
- This modification required a comprehensive redesign of the gearbox casing and bearing arrangement to accommodate the new configuration

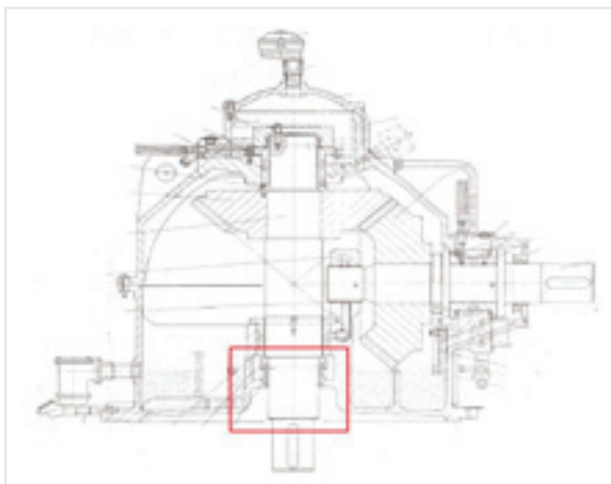
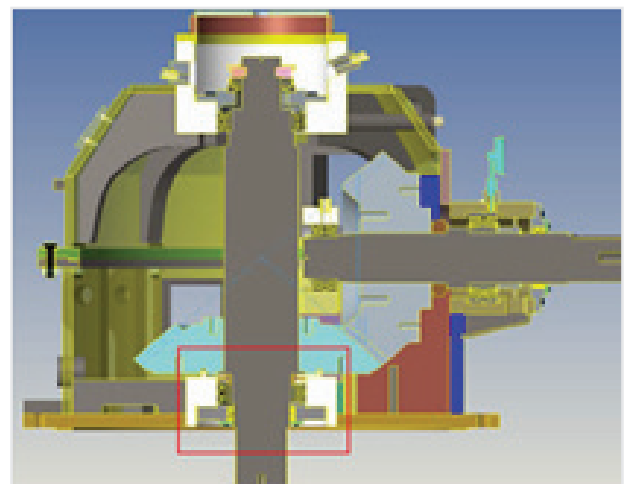
- Repositioning of the bevel gear mesh significantly altered the load path within the gearbox
- The new configuration brought the bevel gear forces closer to the gearbox foundation, thereby reducing cantilever effects
- This design enhancement resulted in improved structural rigidity and load distribution
- Overall, the re-engineered configuration contributed to greater robustness and operational reliability
