## COMPRESSOR GEARBOX (FERTILIZER INDIA)

### 1 TECHNICAL DATA:

### 2 PREAMBLE / PROBLEM REPORTED

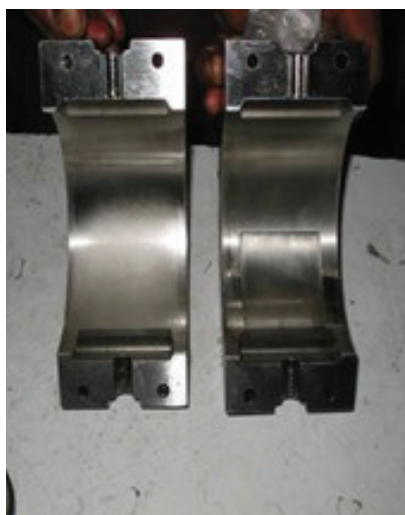
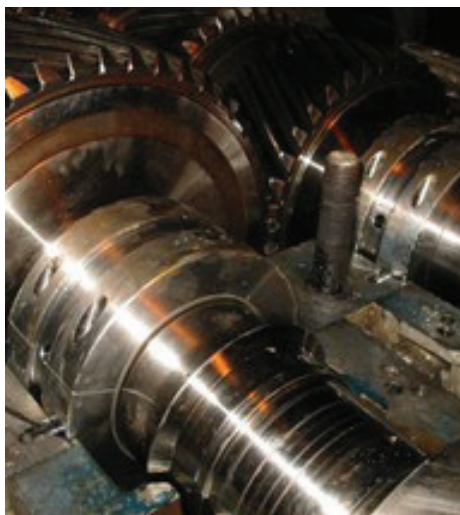
- Progressive increase in thrust clearance at the output shaft
- High casing vibration levels at the low-speed drive end bearing
- Misalignment between steam turbine, LP compressor, gearbox, and HP compressor shafts
- Increasing gap voltage readings from shaft vibration probes
- Uneven bearing clearance growth across the shaft length

- The primary root cause was identified as misalignment and level deviations, resulting in additional loads on the bearings
- Bearing loads exceeded permissible limits, leading to accelerated wear and frequent failures
- Correlation between casing vibration and probe data confirmed systematic bearing overload conditions
- Uneven bearing clearance altered dynamic gear tooth contact, causing localized overloading and subsequent gear pitting

- Conducted detailed engineering analysis and load calculations
- Increased bearing bore diameter and width, reducing bearing specific load from 34 kg/cm<sup>2</sup> to 27 kg/cm<sup>2</sup>
- Introduced a controlled shaft offset (0.06 mm) relative to the input shaft to compensate for thermal growth
- Replaced foundation dowels with precision-fit dowel plates to ensure proper alignment retention
- Optimized alignment protocol:
- Maintained vertical offset
- Reduced horizontal offset by 50% to minimize growth-induced loads
- Maintained DBSE at axial mean position to ensure balanced load distribution during operation
