## STEAM TURBINE GEARBOX (CPP – KENYA)

### 2 PREAMBLE / PROBLEM REPORTED

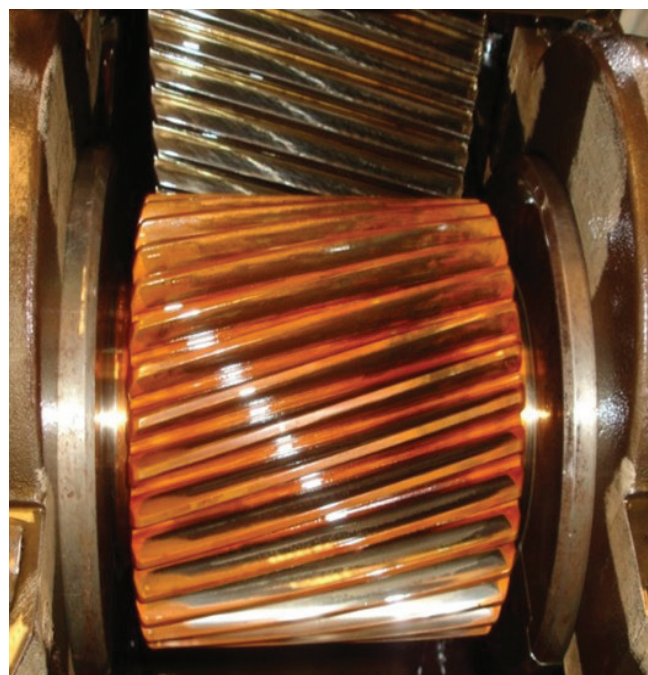
- High axial vibration developed within 2–3 days of operation
- Elevated vibration levels were recorded across all bearing locations, with the highest value of 6 mm/sec at the gear NDE side
- The increase in vibration was sudden and non-linear in nature
- Dominant vibration frequency corresponded to 1X gear rotational speed
- Significant 2X and 3X components in axial direction were observed
- Harmonics of gear rotational speed appeared after a few hours of operation
- Vibration spectrum predominantly showed gear-related frequencies (GMF)

- The dominant vibration in the axial direction ruled out typical gear mesh-related issues and internal misalignment
- Absence of vibration increase linked to turbine speed indicated that turbine–gearbox alignment was not the cause
- Time-dependent nature of vibration ruled out looseness or inherent bearing design defects
- Analysis pointed towards thermal growth mismatch and coupling-related constraints
- Higher vibration at the gear shaft NDE side, where the thrust bearing is located, indicated axial force transmission through the coupling
- The root cause was identified as incorrect coupling selection (gear coupling), which restricted axial movement and induced axial loading

- Identified mismatch in axial and radial growth between the gearbox shaft and alternator shaft, leading to coupling locking.
- Replaced the existing gear coupling with a flexible coupling, capable of accommodating misalignment and thermal expansion.
- This modification enabled absorption of axial movement and eliminated induced stresses.
