## COMPRESSOR GEARBOX (FERTILIZER SOUTH – INDIA)

### 2 PREAMBLE / PROBLEM REPORTED

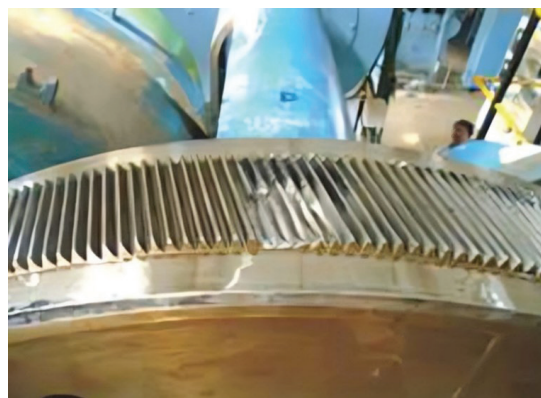
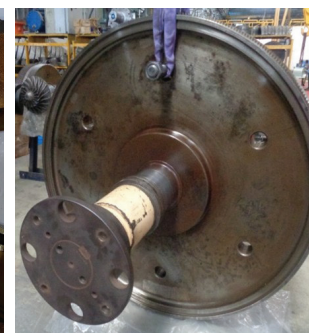
- Multiple tooth fractures on the bull gear wheel, indicating severe mechanical distress.
- Failure of tilting pad bearings and air seals.
- Historical vibration analysis showed the presence of 1X GRT stage frequency across all shafts, indicating system-wide dynamic influence.
- Maintenance records confirmed repetitive failures in the GRT stage pinion and associated bearings.
- Critical bearing pad dimensions were captured using precision measurement techniques (CMM).

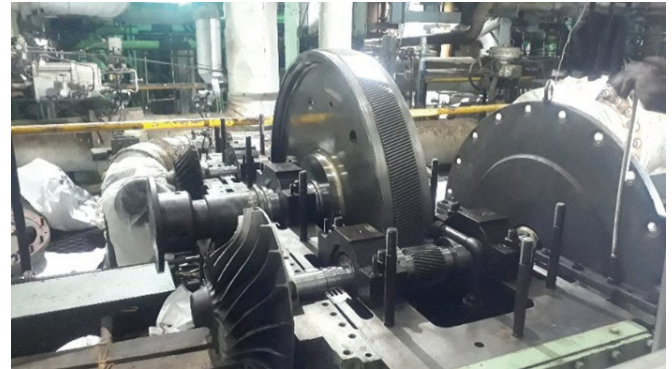
- The primary root cause was identified as fatigue failure of the bull gear and bearings
- Uneven clearance in the GRT stage volute casing contributed to vibration amplification and cyclic loading
- Existing air seal and bearing designs were inadequate for handling operational stresses and required redesign
- The combined effect of vibration, clearance variation, and design limitations led to progressive damage and eventual system failure
