## BLOWER GEARBOX (FERTILIZER – INDIA)

### 2 PREAMBLE / PROBLEM REPORTED

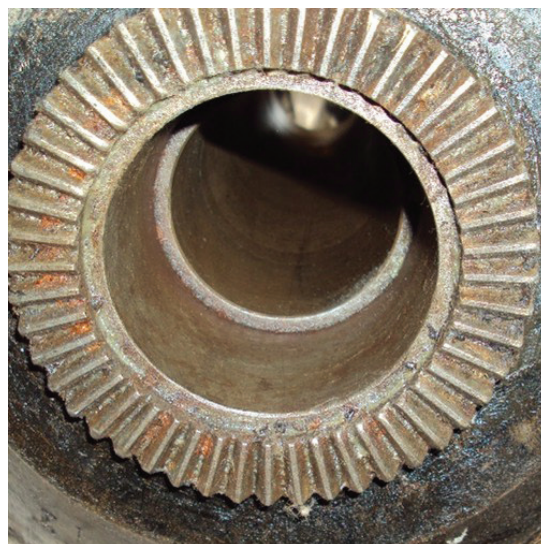
- Severe damage to gear and pinion, including the Hirth gear interface
- Critical Hirth gear dimensions on the blower impeller were captured using precision measurement techniques (CMM)
- Failure pattern indicated fatigue-induced damage of gear internals

- The root cause was identified as fatigue failure of the gear system, resulting from cyclic loading over time
- Damage extended to the Hirth gear interface, a critical component for torque transmission to the blower impeller
- Restoration required accurate replication of gear geometry, including the Hirth interface, to ensure proper mating and performance
- Reverse engineering approach was essential due to the complexity and precision required.

- Developed complete gear internals through reverse engineering, achieving delivery in approximately 50% of OEM lead time
- Precisely reproduced the Hirth gear interface to ensure accurate fitment with the blower impeller
- Manufactured a new gear set using case-hardened material to improve durability and fatigue resistance
- Assembled and commissioned the gearbox after thorough validation
