## STEAM TURBINE DRIVE GEARBOX (CEMENT – SOUTH, INDIA)

### 1 TECHNICAL DATA:

### 2 PREAMBLE / PROBLEM REPORTED

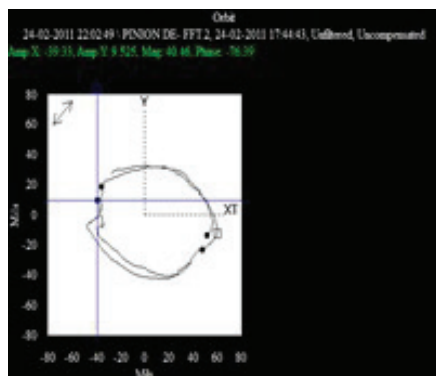
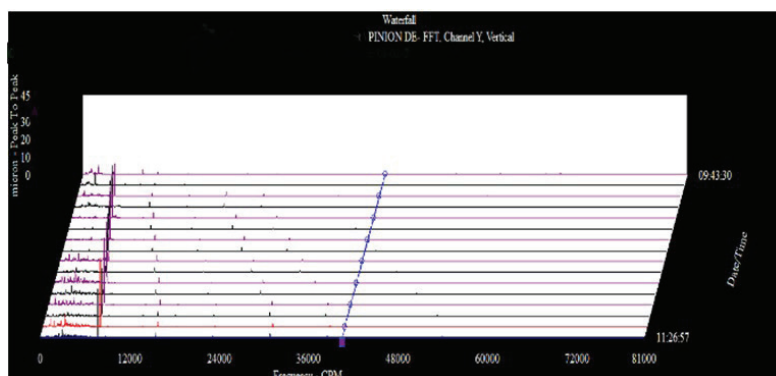
- Dominant 1X rotational frequency observed across all speeds in both horizontal and vertical directions
- Shaft orbit patterns were circular with multiple node points, perpendicular to gear separation forces
- Increase in vibration levels coincided with the onset of abnormal noise
- The measured Distance Between Shaft Ends (DBSE) was found to be shorter than the coupling spacer, indicating coupling compression instead of pre-stretch

- The dominant 1X vibration indicated shaft preloading rather than imbalance-related issues
- Orbit analysis / slow roll vector ruled out shaft runout as a potential cause
- The issue was traced to improper coupling pre-stretch, resulting in axial loading of the shaft
- This condition led to helix locking on one side of the gear, causing excessive vibration and abnormal noise

- DBSE was accurately re-measured under operating conditions
- The mismatch was corrected by removing 2.8 mm of shim from the coupling assembly
- Alignment was revalidated to ensure proper shaft positioning and coupling behaviour
