## STEAM TURBINE GEARBOX (CEMENT –WEST, INDIA)

Premature gear failure was reported in the steam turbine generator (STG) gearbox at a cement plant, leading to repeated shutdowns and reduced reliability.

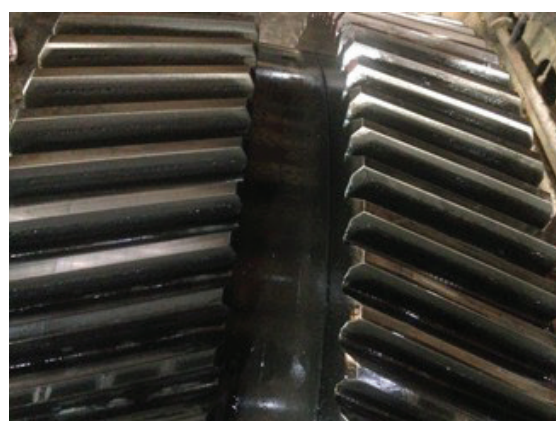
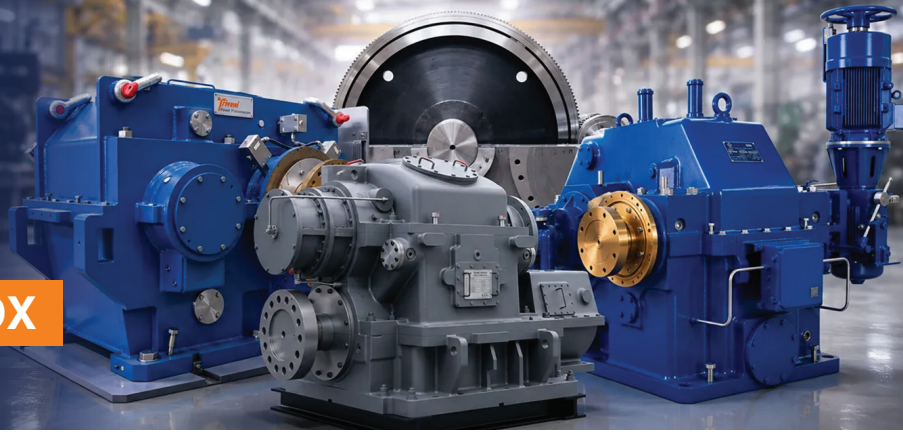
- Severe pitting observed on the pinion shaft gear teeth
- OEM-supplied replacement gear also exhibited premature failure within a short duration
- The STG was operating in island mode, exposing the system to higher transient loads
- Maintenance records confirmed repetitive gear damage despite prior corrective interventions

- The root cause was identified as inadequate consideration of transient operating conditions during the original gearbox design
- Operation in island mode introduced frequent load fluctuations and short-circuit torque conditions, significantly increasing stress on gear teeth
- These transient loads were not sufficiently accounted for in the OEM design, leading to premature pitting and repeated failures
- The mismatch between operating conditions and design limits resulted in reduced gear life and reliability

- Performed detailed design analysis incorporating island mode operating conditions
- Factored in short-circuit torque and grid/load fluctuations into gear design calculations
- Developed and manufactured new gear internals with improved material properties and optimized geometry to withstand transient stresses
- Ensured compatibility with existing gearbox configuration while enhancing durability
- Alignment was revalidated to ensure proper shaft positioning and coupling behaviour
