## STEAM TURBINE GEARBOX (SUGAR –NORTH INDIA)

### 1 TECHNICAL DATA:

### 2 PREAMBLE / PROBLEM REPORTED

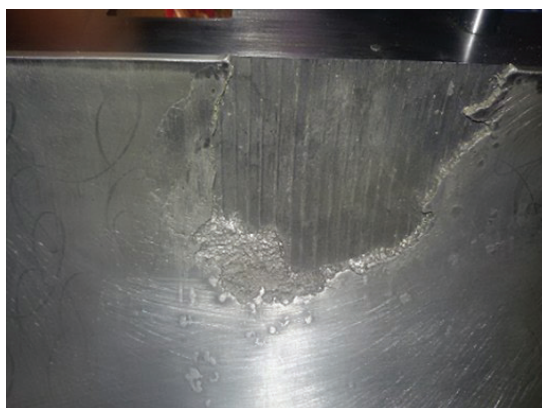
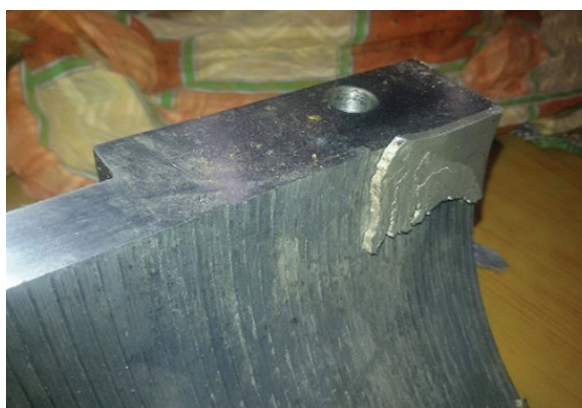
- Pinion NDE bearing temperature reached up to 110°C at a load of 17 MW
- White metal layer rupture and peeling from the bearing shell
- Shaft to bearing blue bedding showed evidence of localized loading towards the gear teeth side
- Casing bore skew resulting in taper contact at the pinion NDE bearing
- Bearing clearances were initially within design limits prior to trial run
- Alignment of high-speed and low-speed shafts was found within OEM tolerances

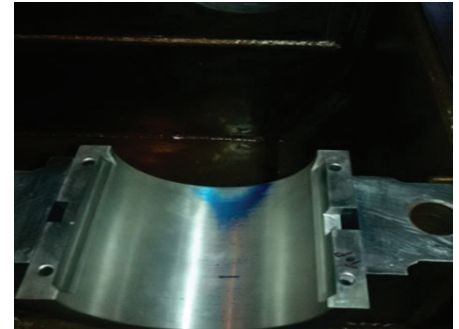
- The root cause was identified as side loading of the offset bearing due to misalignment effects
- Offset bearings are inherently more sensitive to shaft positioning and alignment variations compared to pressure dam bearings
- Localized contact near the joint line resulted in increased load per unit area, leading to excessive stress
- This condition led to elevated operating temperatures and repetitive bearing failures
