## NITROGEN COMPRESSOR GEARBOX (REFINERY, MALAYSIA)

### 2 PREAMBLE / PROBLEM REPORTED

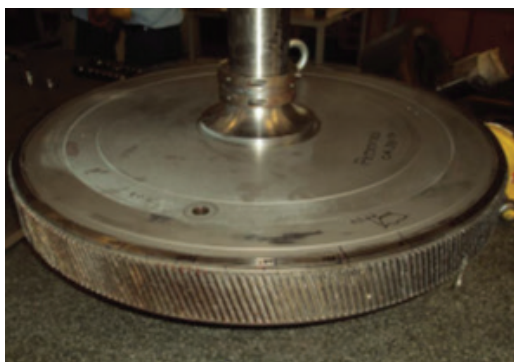
- Severe gear tooth damage and scoring on shaft journals
- Complete wear of the Hirth gear on the pinion assembly
- Broken and sheared casing studs at the parting plane
- Dents and damage marks on casing bores, indicating structural impact

Damaged Input Geat Wheel

- Designed and manufactured new gear internals and bearings compliant with API 613 (5th Edition)
- Restored casing integrity through re-machining and dimensional correction
- Assembled and tested the gearbox as per API standards
- Conducted no-load trial run testing to validate performance

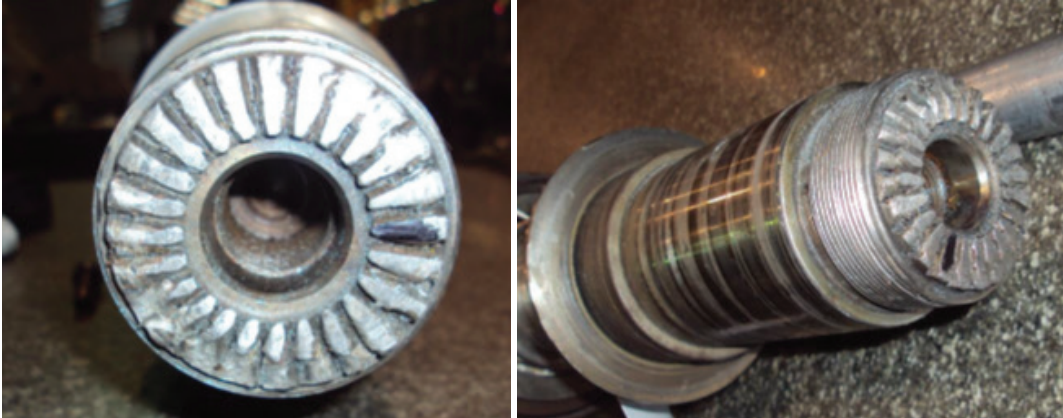
Hirth Gear

- The root cause was identified as external shock loading due to compressor surge, resulting in excessive dynamic stress on gearbox components
- Existing internals were found to be non-compliant with API 613 standards
- The gearbox casing required restoration through precision re-machining
