## STEAM TURBINE GEARBOX (BIOMASS PLANT – SRI LANKA)

### 2 PREAMBLE / PROBLEM REPORTED

During commissioning, the gearbox exhibited high noise and vibration while synchronization, impacting operational stability and reliability.

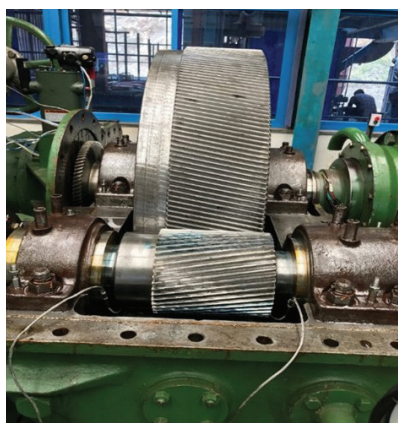
- Gear tooth wear observed on both pinion and gear wheel
- The turbine rotor overhang at the coupling end caused the pinion shaft to behave like an extension of the turbine shaft
- Under load, vibration levels increased significantly, reaching up to 24.6 mm/sec
- High gear mesh frequencies with sidebands indicated improper tooth contact under load conditions
- Dominant vibration observed at 1X turbine speed
- Uneven clearance in coupling bolts, contributing to imbalance and vibration

Tooth wear noticed both in pinion and gear tooth

- The root cause was identified as misalignment and improper centering of the pinion shaft
- The extended shaft behaviour introduced torsional deflection under load, affecting gear meshing
- Improper coupling clearances further aggravated dynamic imbalance and vibration
- Combined effects led to poor contact pattern, increased noise, and excessive vibration levels

- Manufactured a new gear set with optimized helix and profile corrections to accommodate load-induced deflections
- Replaced conventional bearings with pressure dam bearings to improve performance under misalignment conditions
- Performed site reaming of coupling bolt holes to maintain controlled minimum clearance (0.05 mm), eliminating bolt-induced imbalance
- Executed pinion shaft face truing at the NDE side to ensure precise co-axial alignment with the turbine and gearbox axes
- Optimized gear mesh contact (~60% towards alternator side) to accommodate torsional effects during load operations and prevent localized loading
- Post-commissioning hard blue checks confirmed greater than 90% uniform gear contact
