## HYDRO TURBINE GEARBOX (IPP SOUTH - INDIA)

### 2 PREAMBLE / PROBLEM REPORTED

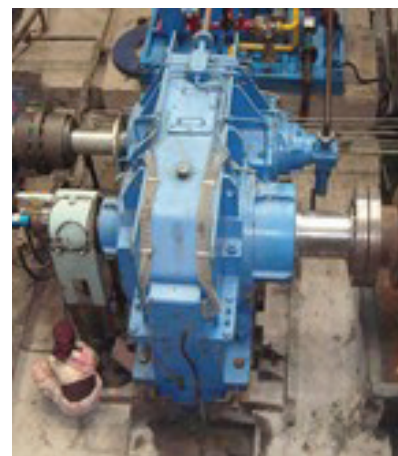
- Turbine and gearbox shaft axes were found to tilt under load conditions by 0.1mm
- End loading observed on gear teeth, indicating uneven load distribution
- Localized tooth damage and pitting observed across the gear profile
- Maintenance history confirmed repetitive gear failures despite prior corrective actions

- The root cause was identified as gear misalignment during load operation, driven by turbine rotor pull. This was causing harmonics of GMF to dominate under higher load conditions.
- Load-induced shaft deflection resulted in uneven contact across the gear face width
- This caused localized stress concentration, leading to progressive tooth wear, pitting, and repeated gear failures
- The existing horizontal gearbox configuration proved inadequate to accommodate shaft displacement under load

- Changed gearbox configuration from horizontal to vertical offset design
- The vertical offset arrangement ensured tooth load contact stability under turbine load conditions, minimizing the impact of shaft deflection
- Designed and supplied new vertical offset gearboxes to replace the existing units
- Successfully implemented across all 10 gearboxes at the plant
- Post-commissioning hard blue checks confirmed greater than 90% uniform gear contact
