## GAS TURBINE – GENERATOR GEARBOX (REFINERY-VIETNAM)

### 2 PREAMBLE / PROBLEM REPORTED

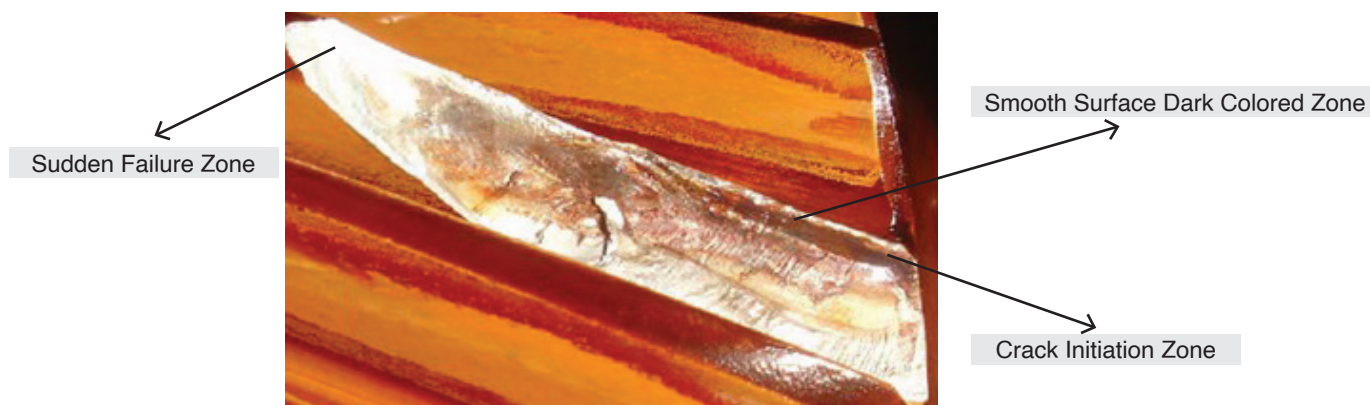
Gearbox exhibited abnormal noise during operation during July 2017. Upon inspection, damage was identified in one tooth of the output gear wheel (LHH), specifically near the apex region. The customer contacted Triveni to diagnose the issue and provide a reliable corrective solution.

- Gearbox casing vibration was 45% higher than normal operating levels
- One tooth of the output gear wheel was damaged near the apex region
- Reduced hardness of approximately 52 HRC was observed near the damaged area
- Surface characteristics of the cracked tooth indicated that the gearbox had been operating with the defect for an extended period
- Bearings, shaft alignment, and torque shaft were inspected and found to be within acceptable limits

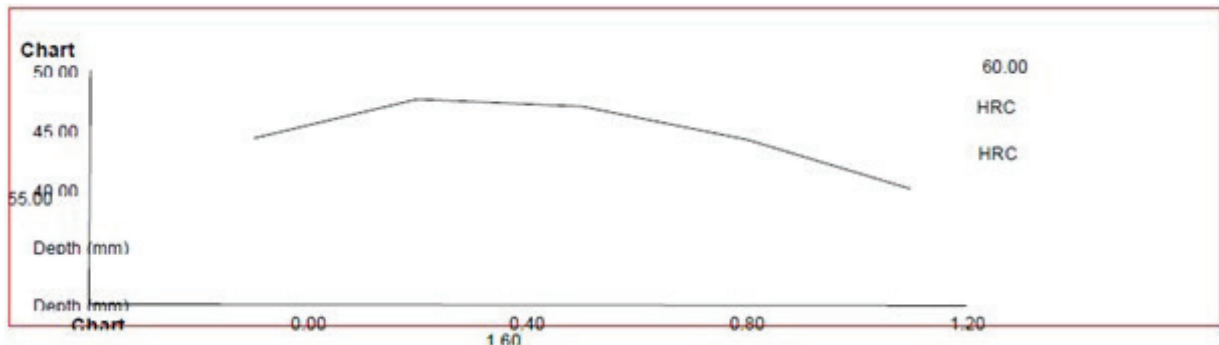
- Excluding for the damaged tooth, all other gear teeth exhibited hardness within the specified range of 57–60 HRC
- The damaged tooth showed localized reduction in hardness (52–55 HRC) near the crack zone
- Crack initiation was traced to the tooth root surface, with evidence of grinding burn during finishing
- Excessive material removal during grinding resulted in localized tempering, leading to reduced hardness and eventual tooth failure

- Supplied new case-carburized gear internals and bearings to enhance durability and performance
- Performed grinding burn testing (roll scan) to validate tooth integrity, stress distribution, and absence of low localised hardness and thermal damage
- Gear internals were assembled and installed at site in November 2008
