## GAS TURBINE LOAD GEARBOX (REFINERY-INDIA)

### 2 PREAMBLE / PROBLEM REPORTED

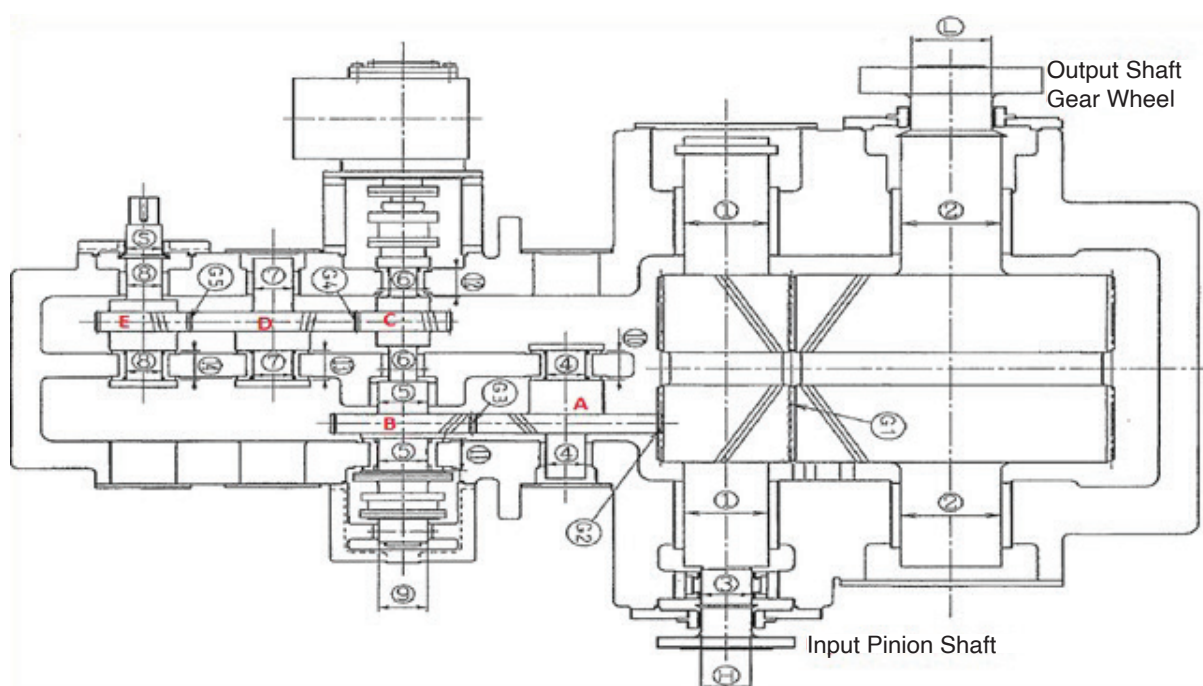
- The Japanese OEM gearboxes were commissioned in 2012. In 2021, the unit began experiencing high vibration and abnormal noise during startup.
- During December 2021, the problem escalated with severe damage to Idler Gear Shaft 3(D), resulting in casing bore damage.
- The OEM recommended complete gearbox replacement with a lead time exceeding 24 months. Considering the operational urgency, the customer approached Triveni for a faster and technically viable repair solution

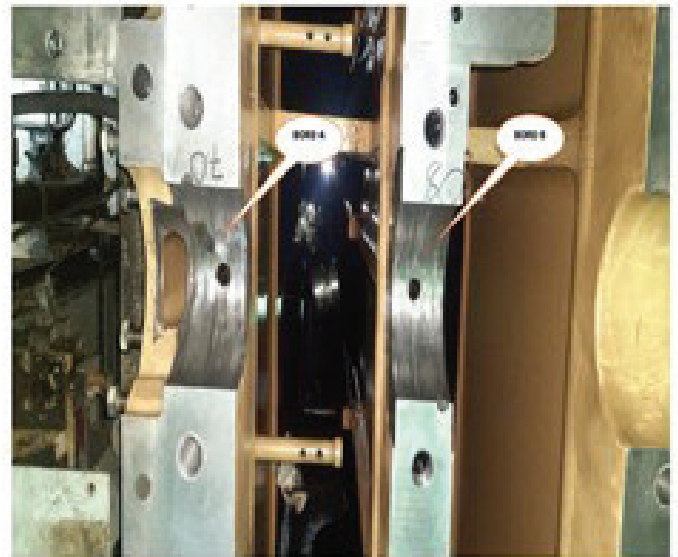
- Significant damage to barring and starting shaft casing bores
- Gearbox casing was grouted to the foundation, making dismantling impractical
- Damage observed in the accessory-side gear set, including the idler assembly
- Overall condition indicated progressive deterioration under operating conditions

- The root cause was identified as continued operation under degraded conditions, aggravated by the absence of temperature and vibration monitoring on the accessory stage
- This led to undetected damage progression, culminating in catastrophic failure
- To address potential misalignment and ensure correct load distribution, gear mesh optimization was required
