## HIGH-SPEED PLANETARY GEARBOX (REFINERY– SOUTH AFRICA)

### 2 PREAMBLE / PROBLEM REPORTED

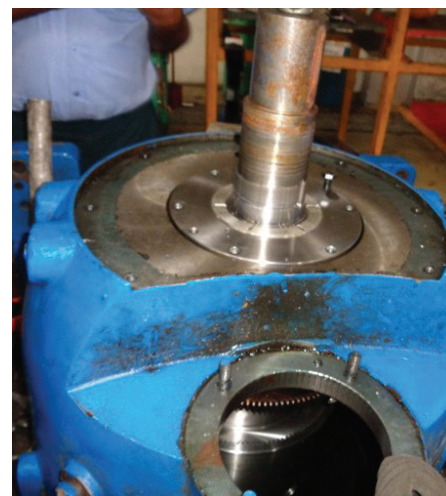
- Failure of the high-speed planetary gearbox led to a complete plant shutdown. The unit had a history of frequent gear and bearing failures, making immediate restoration critical to resume operations.

- Severe pitting on gear teeth, indicating progressive surface fatigue
- Gear components had significantly degraded due to repeated failures
- Bearing clearances were found to be beyond permissible limits
- Critical components including planet gears, annulus ring, and planet pin journals were damaged
- Reverse engineering was not feasible due to the poor condition of the existing parts

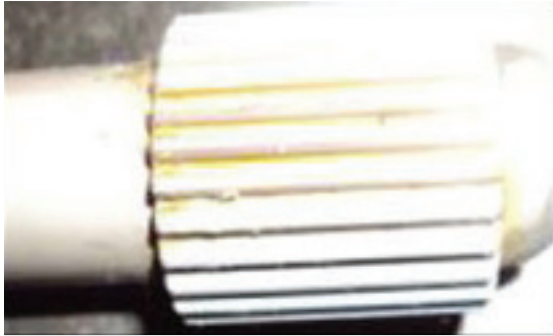
Sun Pinion

- The primary root cause was identified as uneven load distribution across bearings, leading to end loading of gears
- This resulted in localized stress concentrations and initiation of pitting damage
- Repeated operation under deteriorated conditions accelerated progressive gear and bearing failure, ultimately leading to system breakdown

- Designed and manufactured new sun pinion and planet gears, compatible with the existing system configuration
- Supplied a complete set of new gear internals, including annulus ring, planet gears, sun pinion, and planet pins
- Installed new bearings to ensure proper load distribution and operational stability
- Assembled the gearbox and conducted a full-speed, no-load trial run as per standard procedures
