## GAS TURBINE – GENERATOR GEARBOX (IPP INDIA – GUJARAT)

### 2 PREAMBLE / PROBLEM REPORTED

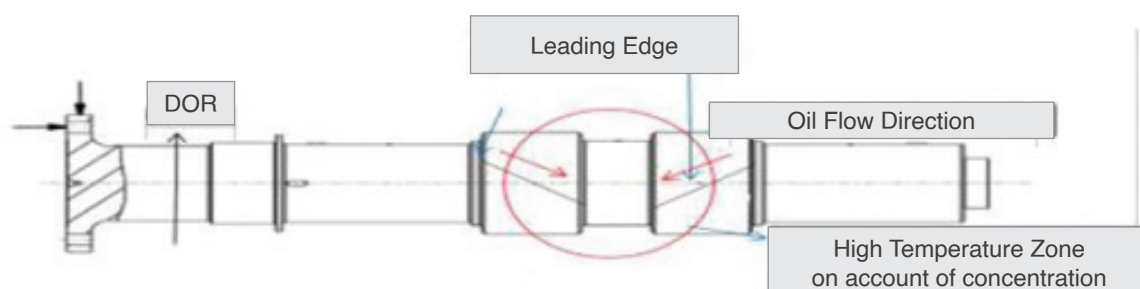
- The root cause was identified as improper heat dissipation across the gear teeth, driven by an unsuitable helix configuration
- The existing helix orientation caused heat concentration at the leading edge, resulting in thermal stress buildup.
- This led to localized overloading and recurring tooth failures in the pinion

- Helix direction modified from diamond configuration to optimized “X-shape”, enabling uniform heat distribution across the tooth face
- Advanced gear parameter optimization, including tooth corrections and load distribution refinement using proprietary engineering tools
- Replacement of tilt pad bearings with pressure dam bearings to improve efficiency and operational stability
- Manufacturing and installation of new gear internals and bearing systems within the existing gearbox casing
- Successful validation through rated speed and 110% overspeed testing
