## STEAM TURBINE GEARBOX (IPP– PHILIPPINES)

### 2 PREAMBLE / PROBLEM REPORTED

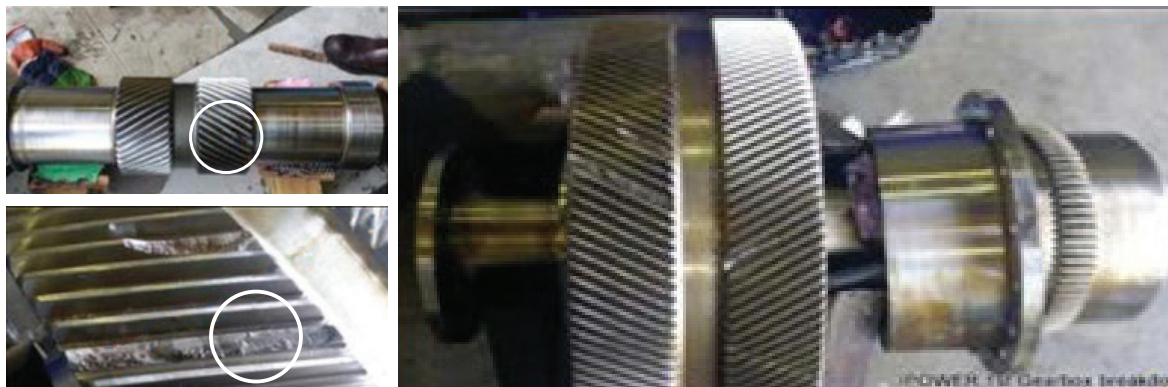
- Tooth failures were observed on both pinion and gear teeth.
- Shaft vibration and bearing temperatures remained within acceptable limits until the onset of abnormal noise.
- Maintenance records revealed consistent failure patterns across both original and replacement gear sets.
- Detailed dimensional inspection and design validation of gear internals and bearings were carried out.

Tooth Failure noticed on both in pinion and gear tooth

The identical failure pattern confirmed a systematic design limitation

- Tooth uprooting indicated insufficient load-carrying capacity under operating conditions
- The gearbox was operating with a service factor of 1.1, significantly below recommended industry standards
- The system was exposed to transient loads due to grid disturbances and short-circuit conditions, which were not adequately accounted for in the original design
- These transient conditions led to localized overloading and repeated gear failures
- This led to localized overloading and recurring tooth failures in the pinion

- Designed a new gearbox with an increased service factor of 1.4, aligned with international standards
- Gear module increased to improve tooth strength and fatigue resistance
- Introduced pressure dam bearings to improve performance under no-load and partial-load conditions and to suppress sub-synchronous vibrations during transient events
