## STEAM TURBINE PLANETARY GEARBOX (IPP – SOUTH INDIA)

### 2 PREAMBLE / PROBLEM REPORTED

Gear failure was reported in the steam turbine generator (STG) planetary gearbox at an IPP unit in South India. The failure resulted in repeated shutdowns and reduced reliability of the generating unit.

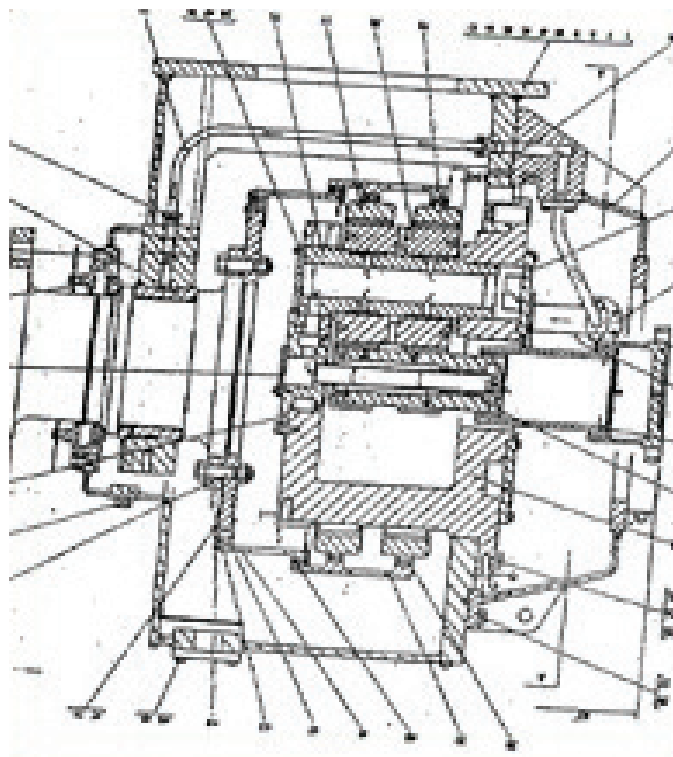
- Pitting observed on sun and planet gears, indicating progressive surface damage
- All bearings were found damaged, requiring replacement
- Maintenance history confirmed recurring gear failures despite prior corrective actions

- The root cause was identified as pin bearing failure due to oil flow blockage.
- Restricted lubrication led to inadequate oil supply, causing localized wear and pitting of gear teeth.
- Subsequent bearing degradation further aggravated gear damage, resulting in repeated failures.

- Designed and manufactured new sun pinion and planet gears compatible with the existing ring gear, in line with Triveni design standards. The oil supply line size was increased to pin bearing to ensure required oil flow through bearing.
- Reassembled the gearbox using new bearings supplied by the customer
- Ensured proper blue contact across both helices of sun and planet gears to achieve uniform load distribution
