## BOOSTER PUMP GEARBOX (IPP – INDIA)

### 2 PREAMBLE / PROBLEM REPORTED

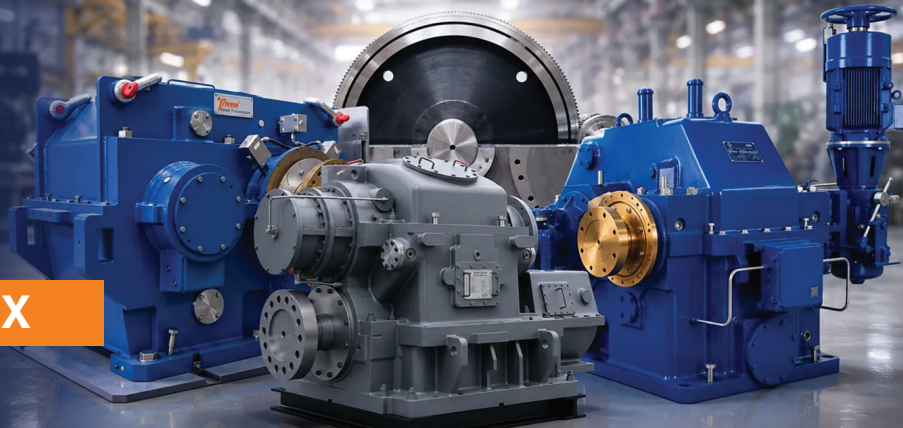
- Severe pitting observed on the high-speed shaft (HSS) coupling-side helix
- Minor pitting and wear on the low-speed shaft (LSS)
- Wear marks identified on tilting pad thrust bearings
- Gearbox casing dowelling was found to significantly influence load distribution across gear elements.

- The root cause was identified as helix-bound operation, resulting in overloading of one side of the gear
- This led to uneven load distribution, causing localized stress, excessive wear, and premature failure
- Thermal expansion of the gearbox casing contributed to one-sided loading on the HSS bearing, further aggravating the condition

- Designed a new gearbox with enhanced axial float to accommodate thermal growth
- Ensured controlled axial float in the pinion shaft coupling, maintaining the gear mesh at the center of float range
- Optimized casing dowelling (at the HSS end only) to prevent asymmetric loading due to thermal expansion
- Manufactured and assembled new gearsets and bearings with improved load distribution characteristics
