## COMPRESSOR GEARBOX (FERTILIZER NORTH – INDIA)

### 1 TECHNICAL DATA:

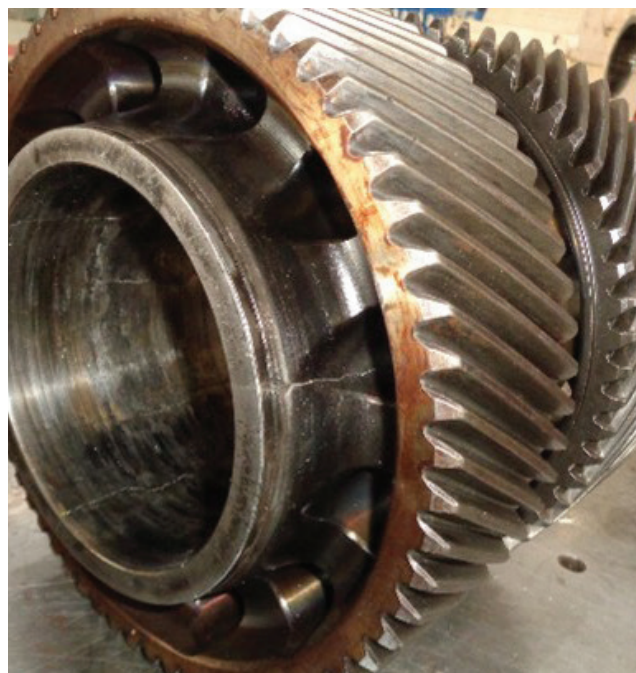
A comprehensive inspection and condition assessment identified the following:

- White metal rupture in the planet pin bearings, indicating severe load-related distress
- Resultant damage to planet gears and ring gears
- High casing vibration levels during operation
- Failure of the leaf spring pack, affecting system stability

- The root cause was identified as overloading of bi-metal pin bearings, which were inadequate for the operating load conditions
- Insufficient load-carrying capacity led to bearing rupture, triggering cascading damage to gears
- Repeated failures were attributed to non-uniform load distribution and inadequate system stiffness

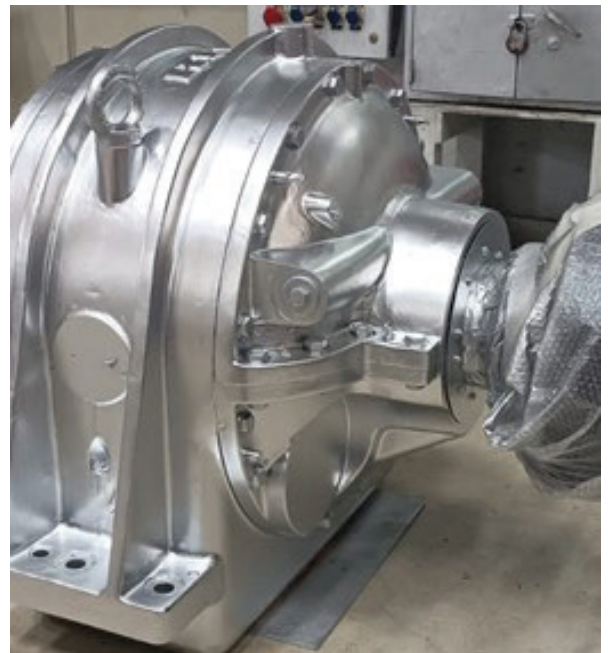
Triveni implemented a comprehensive design upgrade to enhance load capacity & system stability:

- Introduced tri-metal pin bearings with significantly higher load-carrying capability
- Ensured individual balancing of planet gears and planet carrier with pins for uniform load distribution
- Optimized axial positioning of the ring gear to achieve balanced load sharing
- Designed and installed a new leaf spring with optimized stiffness characteristics
