## STEAM TURBINE GEARBOX (STEEL PLANT-INDIA)

### 1 TECHNICAL DATA:

### 2 PREAMBLE / PROBLEM REPORTED

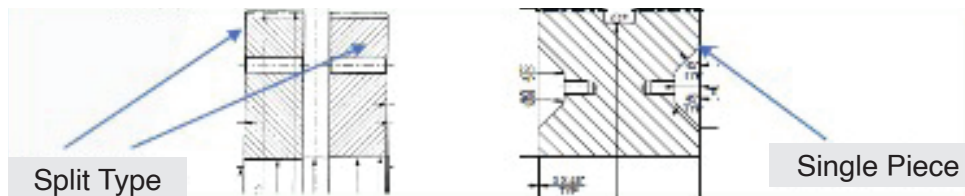
- Supplied new gear internals along with bearings
- Replaced the split-type double helical gear wheel with a single-piece gear wheel design to eliminate relative movement
- Optimized gear wheel mass elastic characteristics to match existing split design value, ensuring improved shrink fit locking.
