## COMPRESSOR GEARBOX (FERTILIZER INDIA)

### 1 TECHNICAL DATA:

### 2 PREAMBLE / PROBLEM REPORTED

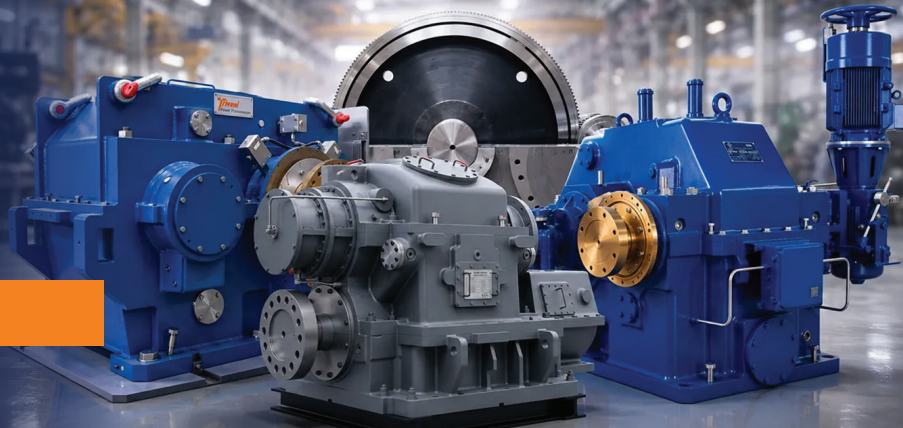
The gearbox experienced frequent and repetitive failures of low-speed shaft (LSS) bearings, occurring approximately every two months.

Additionally, repeated failures of the intermediate pinion drive end (DE) bearing, along with thrust clearance issues and gear pitting, significantly impacted equipment reliability and plant availability.

- Progressive increase in thrust clearance at the output shaft
- High casing vibration levels at the low-speed drive end bearing
- Misalignment between steam turbine, LP compressor, gearbox, and HP compressor shafts
- Increasing gap voltage readings from shaft vibration probes
- Uneven bearing clearance growth across the shaft length

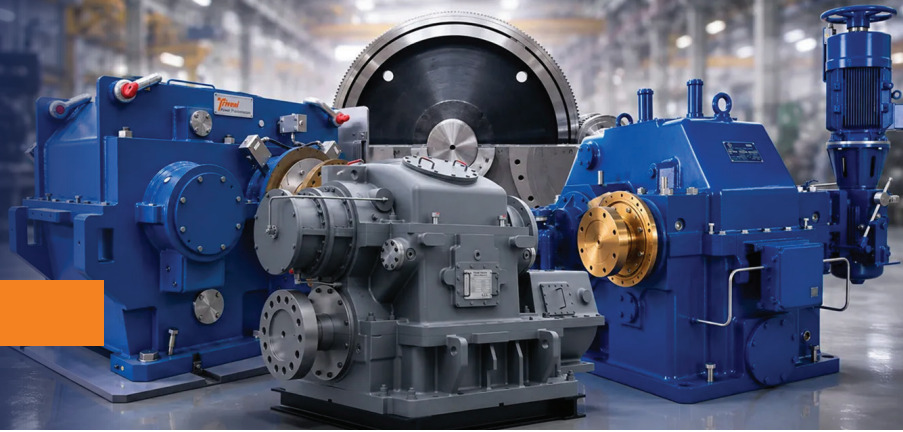
- The primary root cause was identified as misalignment and level deviations, resulting in additional loads on the bearings
- Bearing loads exceeded permissible limits, leading to accelerated wear and frequent failures
- Correlation between casing vibration and probe data confirmed systematic bearing overload conditions
- Uneven bearing clearance altered dynamic gear tooth contact, causing localized overloading and subsequent gear pitting

- Conducted detailed engineering analysis and load calculations
- Increased bearing bore diameter and width, reducing bearing specific load from 34 kg/cm<sup>2</sup> to 27 kg/cm<sup>2</sup>
- Introduced a controlled shaft offset (0.06 mm) relative to the input shaft to compensate for thermal growth
- Replaced foundation dowels with precision-fit dowel plates to ensure proper alignment retention
- Optimized alignment protocol:
- Maintained vertical offset
- Reduced horizontal offset by 50% to minimize growth-induced loads
- Maintained DBSE at axial mean position to ensure balanced load distribution during operation
