## COMPRESSOR GEARBOX (FERTILIZER SOUTH – INDIA)

### 2 PREAMBLE / PROBLEM REPORTED

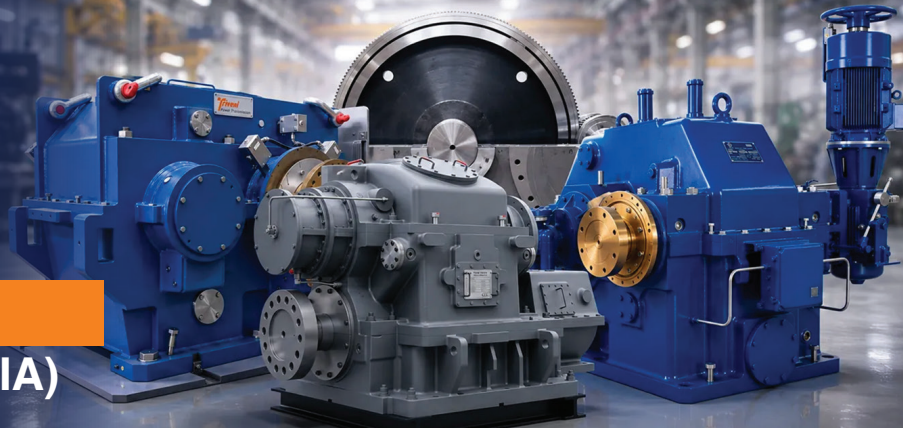
During 2015, the unit experienced multiple failures, including bull gear tooth fractures, tilting pad bearing failures, and air seal damage, leading to a complete shutdown of the fertilizer plant.

- Multiple tooth fractures on the bull gear wheel, indicating severe mechanical distress.
- Failure of tilting pad bearings and air seals.
- Historical vibration analysis showed the presence of 1X GRT stage frequency across all shafts, indicating system-wide dynamic influence.
- Maintenance records confirmed repetitive failures in the GRT stage pinion and associated bearings.
- Critical bearing pad dimensions were captured using precision measurement techniques (CMM).

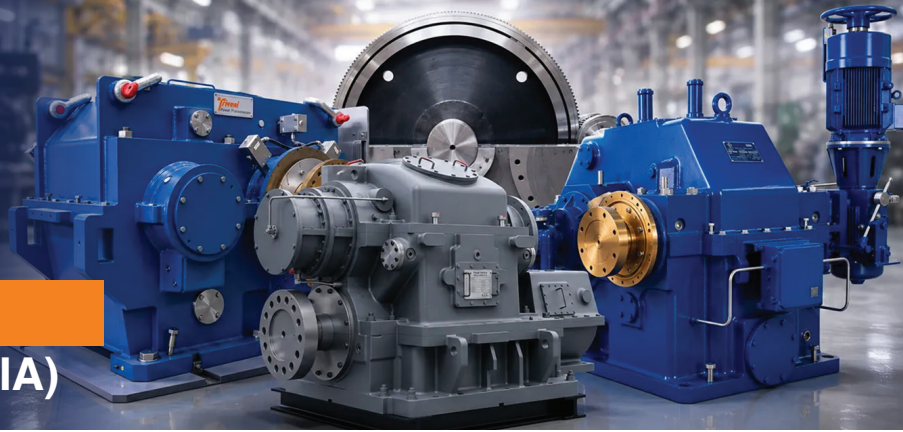
- The primary root cause was identified as fatigue failure of the bull gear and bearings
- Uneven clearance in the GRT stage volute casing contributed to vibration amplification and cyclic loading
- Existing air seal and bearing designs were inadequate for handling operational stresses and required redesign
- The combined effect of vibration, clearance variation, and design limitations led to progressive damage and eventual system failure
