## BLOWER GEARBOX (FERTILIZER – INDIA)

### 2 PREAMBLE / PROBLEM REPORTED

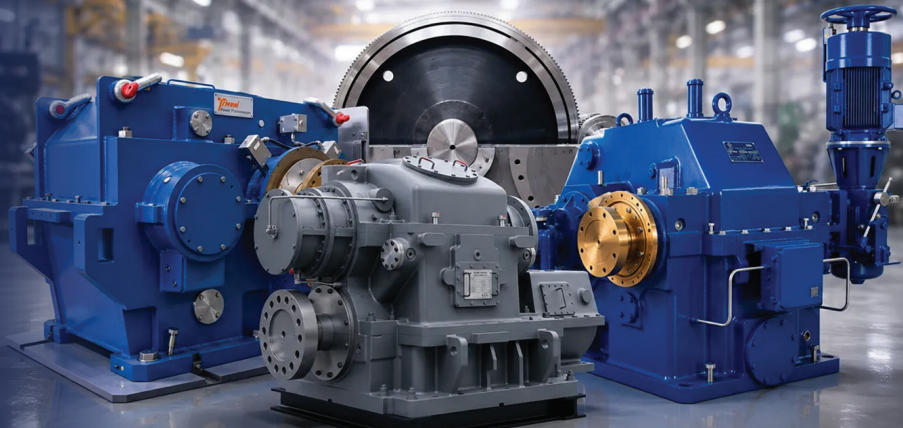
Failure of gears was reported in the blower gearbox, resulting in abnormal operation and plant shutdown.

- Severe damage to gear and pinion, including the Hirth gear interface
- Critical Hirth gear dimensions on the blower impeller were captured using precision measurement techniques (CMM)
- Failure pattern indicated fatigue-induced damage of gear internals

- The root cause was identified as fatigue failure of the gear system, resulting from cyclic loading over time
- Damage extended to the Hirth gear interface, a critical component for torque transmission to the blower impeller
- Restoration required accurate replication of gear geometry, including the Hirth interface, to ensure proper mating and performance
- Reverse engineering approach was essential due to the complexity and precision required.
