## STEAM TURBINE DRIVE GEARBOX (CEMENT – SOUTH, INDIA)

### 1 TECHNICAL DATA:

### 2 PREAMBLE / PROBLEM REPORTED

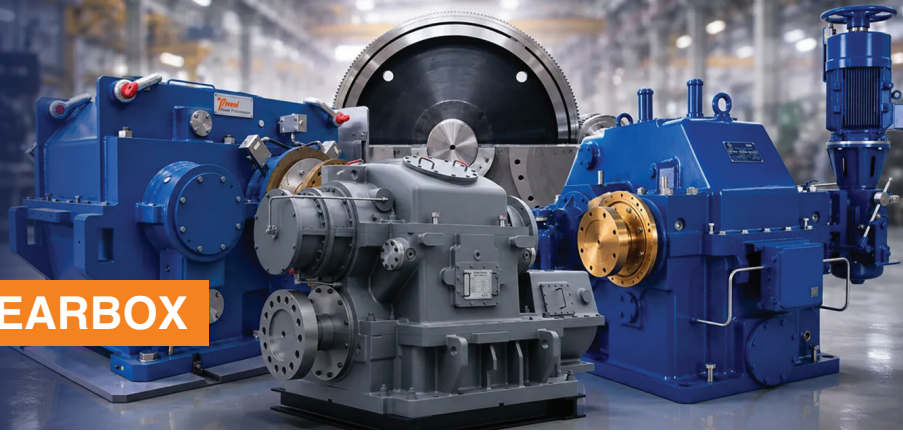
- Dominant 1X rotational frequency observed across all speeds in both horizontal and vertical directions
- Shaft orbit patterns were circular with multiple node points, perpendicular to gear separation forces
- Increase in vibration levels coincided with the onset of abnormal noise
- The measured Distance Between Shaft Ends (DBSE) was found to be shorter than the coupling spacer, indicating coupling compression instead of pre-stretch

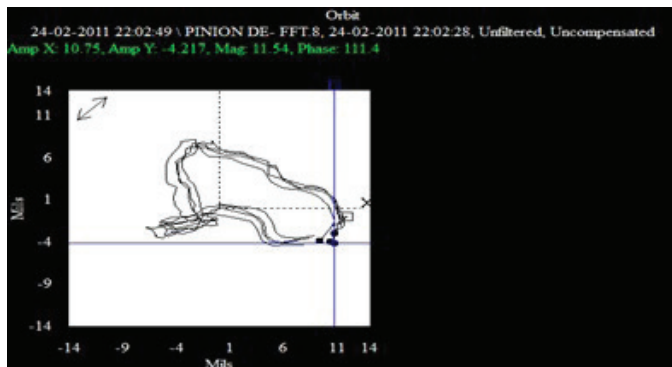
- The dominant 1X vibration indicated shaft preloading rather than imbalance-related issues
- Orbit analysis / slow roll vector ruled out shaft runout as a potential cause
- The issue was traced to improper coupling pre-stretch, resulting in axial loading of the shaft
- This condition led to helix locking on one side of the gear, causing excessive vibration and abnormal noise

- DBSE was accurately re-measured under operating conditions
- The mismatch was corrected by removing 2.8 mm of shim from the coupling assembly
- Alignment was revalidated to ensure proper shaft positioning and coupling behaviour
