## STEAM TURBINE GEARBOX (SUGAR –NORTH INDIA)

### 1 TECHNICAL DATA:

### 2 PREAMBLE / PROBLEM REPORTED

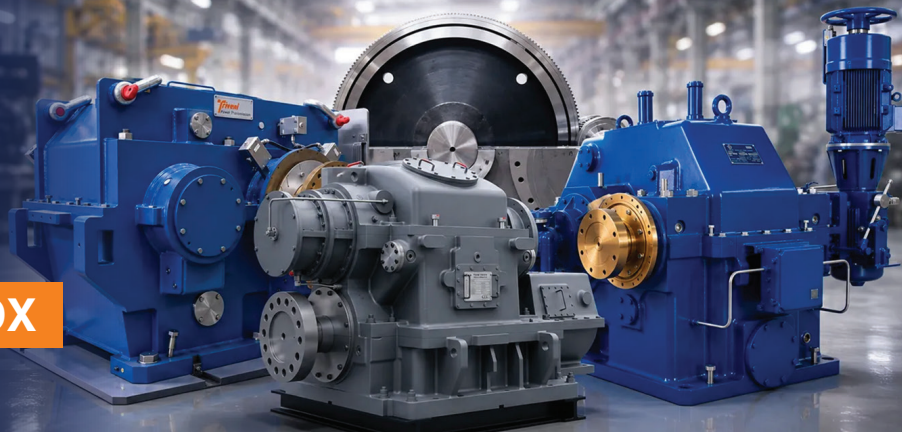
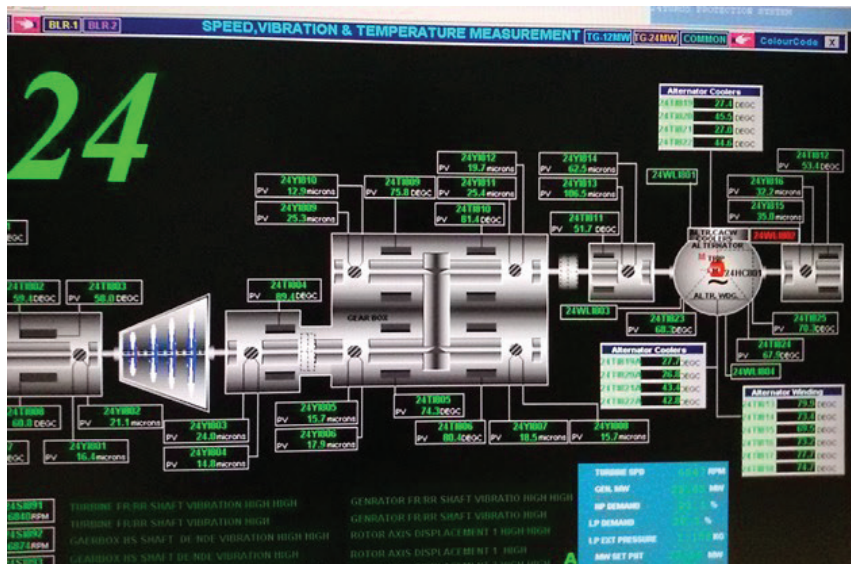
- Bearing temperatures stabilized within acceptable limits
- Vibration levels remained normal
- Overall gearbox performance improved significantly

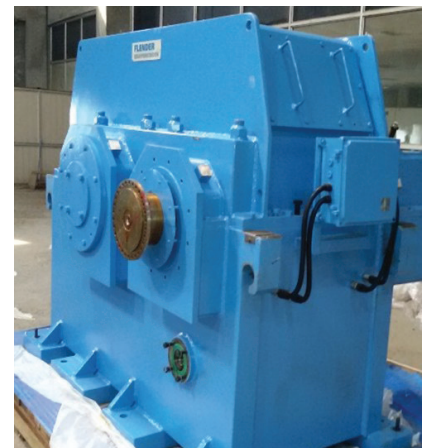
The gearbox was successfully **refurbished and recommissioned**, restoring reliable operation.

- Elimination of frequent high-speed bearing failures
- Improved reliability through advanced bearing design
- Stable operating temperatures and vibration levels
- Consistent performance with all parameters within permissible limits
