## NITROGEN COMPRESSOR GEARBOX (REFINERY, MALAYSIA)

### 2 PREAMBLE / PROBLEM REPORTED

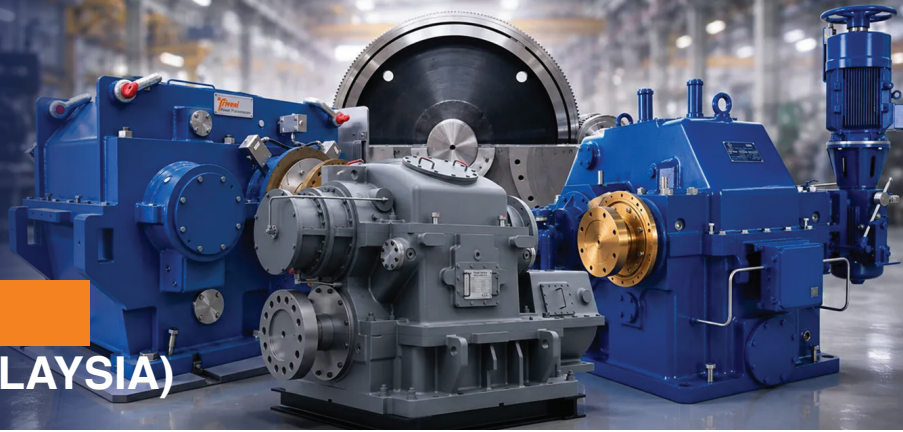
- Severe gear tooth damage and scoring on shaft journals
- Complete wear of the Hirth gear on the pinion assembly
- Broken and sheared casing studs at the parting plane
- Dents and damage marks on casing bores, indicating structural impact

- The root cause was identified as external shock loading due to compressor surge, resulting in excessive dynamic stress on gearbox components
- Existing internals were found to be non-compliant with API 613 standards
- The gearbox casing required restoration through precision re-machining

- Designed and manufactured new gear internals and bearings compliant with API 613 (5th Edition)
- Restored casing integrity through re-machining and dimensional correction
- Assembled and tested the gearbox as per API standards
- Conducted no-load trial run testing to validate performance

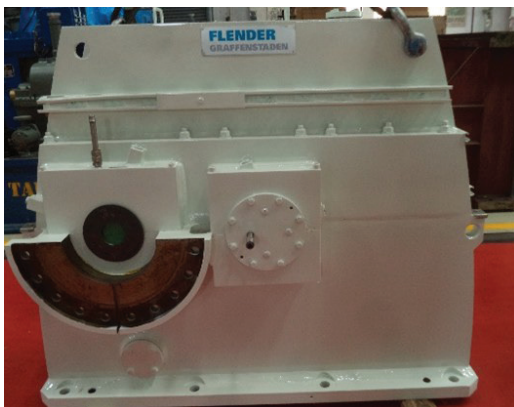
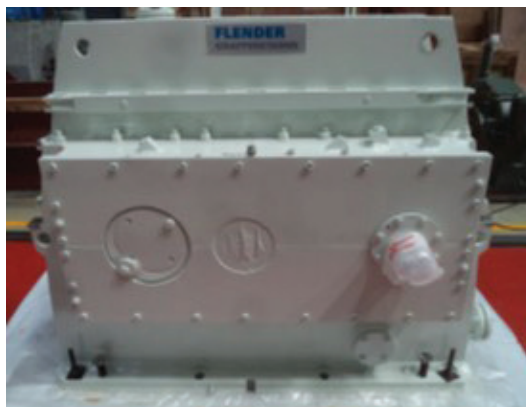
- Bearing temperatures and shaft vibrations were within acceptable API limits
- Stable and reliable gearbox performance
