## HYDRO TURBINE GEARBOX (IPP SOUTH - INDIA)

### 2 PREAMBLE / PROBLEM REPORTED

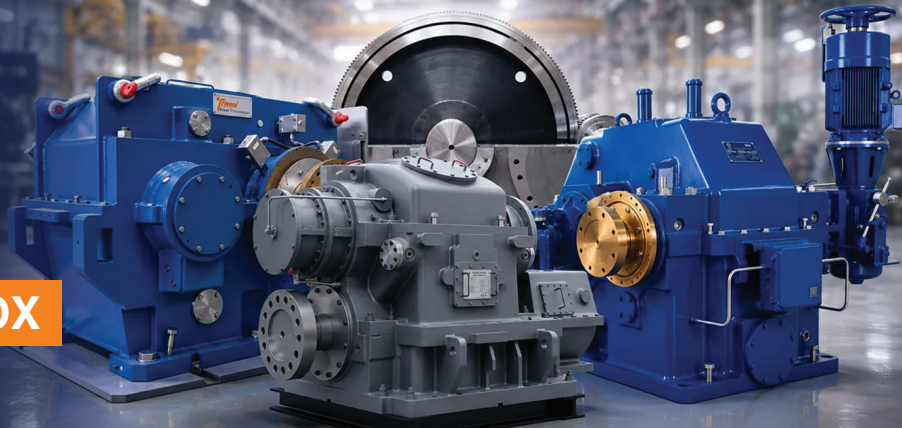
Frequent failures of gear teeth were reported in the hydro turbine gearbox, leading to repeated shutdowns and reduced reliability of the generating unit. Despite multiple corrective interventions, the issue persisted, significantly impacting plant availability and performance.

- Turbine and gearbox shaft axes were found to tilt under load conditions by 0.1mm
- End loading observed on gear teeth, indicating uneven load distribution
- Localized tooth damage and pitting observed across the gear profile
- Maintenance history confirmed repetitive gear failures despite prior corrective actions

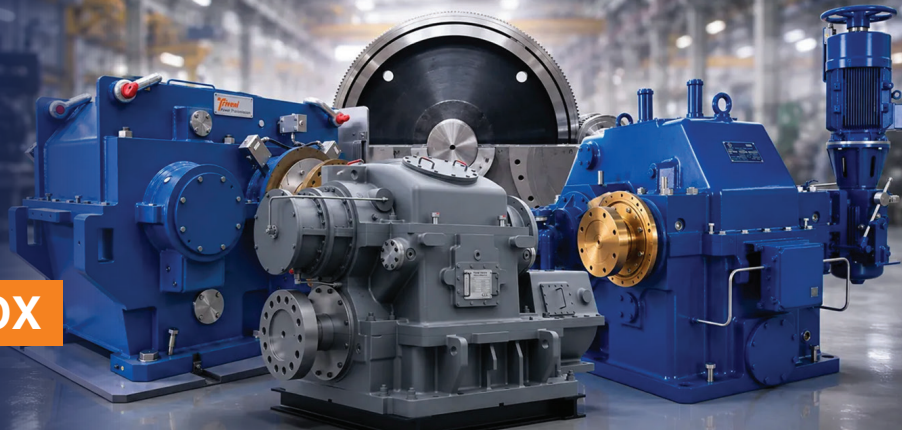
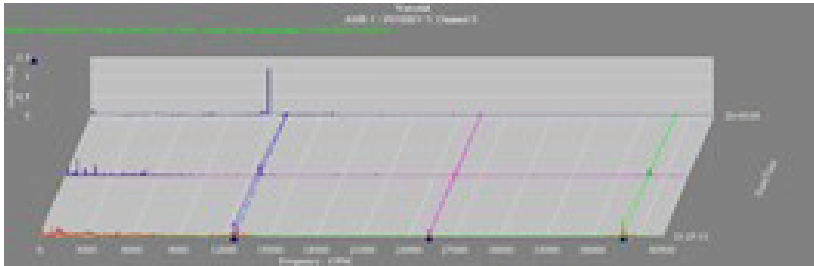
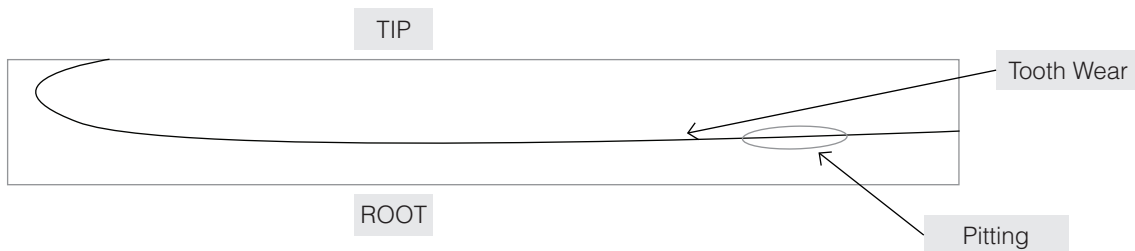
- The root cause was identified as gear misalignment during load operation, driven by turbine rotor pull. This was causing harmonics of GMF to dominate under higher load conditions.
- Load-induced shaft deflection resulted in uneven contact across the gear face width
- This caused localized stress concentration, leading to progressive tooth wear, pitting, and repeated gear failures
- The existing horizontal gearbox configuration proved inadequate to accommodate shaft displacement under load

- Changed gearbox configuration from horizontal to vertical offset design
- The vertical offset arrangement ensured tooth load contact stability under turbine load conditions, minimizing the impact of shaft deflection
- Designed and supplied new vertical offset gearboxes to replace the existing units
- Successfully implemented across all 10 gearboxes at the plant
- Post-commissioning hard blue checks confirmed greater than 90% uniform gear contact
