## GAS TURBINE – GENERATOR GEARBOX (REFINERY-VIETNAM)

### 2 PREAMBLE / PROBLEM REPORTED

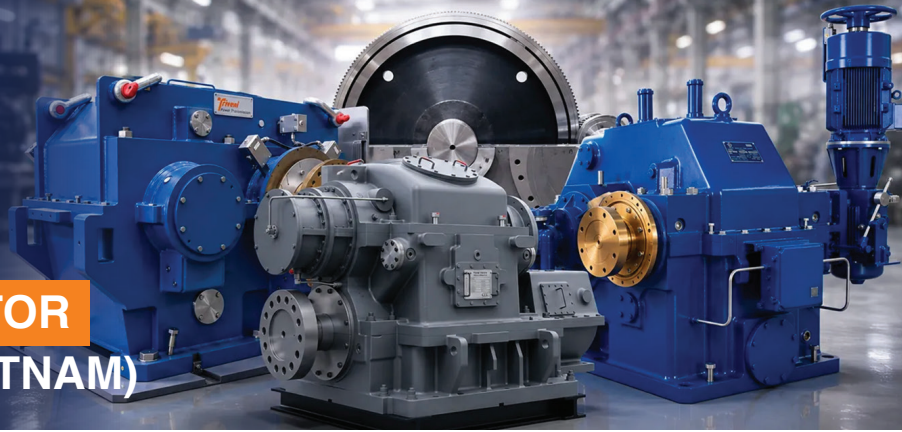
- Excluding for the damaged tooth, all other gear teeth exhibited hardness within the specified range of 57–60 HRC
- The damaged tooth showed localized reduction in hardness (52–55 HRC) near the crack zone
- Crack initiation was traced to the tooth root surface, with evidence of grinding burn during finishing
- Excessive material removal during grinding resulted in localized tempering, leading to reduced hardness and eventual tooth failure

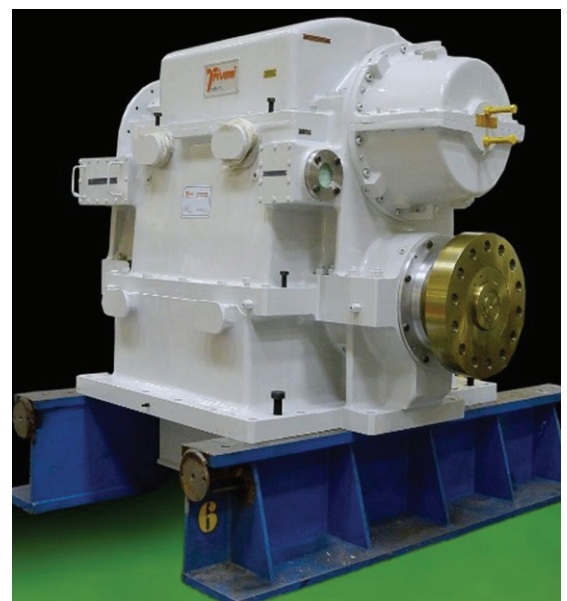
- Maximum casing vibration recorded: 1.6 mm/sec
  - Maximum bearing temperature at full load: 94°C
- All parameters were within acceptable operating limits.

- Supplied new case-carburized gear internals and bearings to enhance durability and performance
- Performed grinding burn testing (roll scan) to validate tooth integrity, stress distribution, and absence of low localised hardness and thermal damage
- Gear internals were assembled and installed at site in November 2008
