## HIGH-SPEED PLANETARY GEARBOX (REFINERY– SOUTH AFRICA)

### 2 PREAMBLE / PROBLEM REPORTED

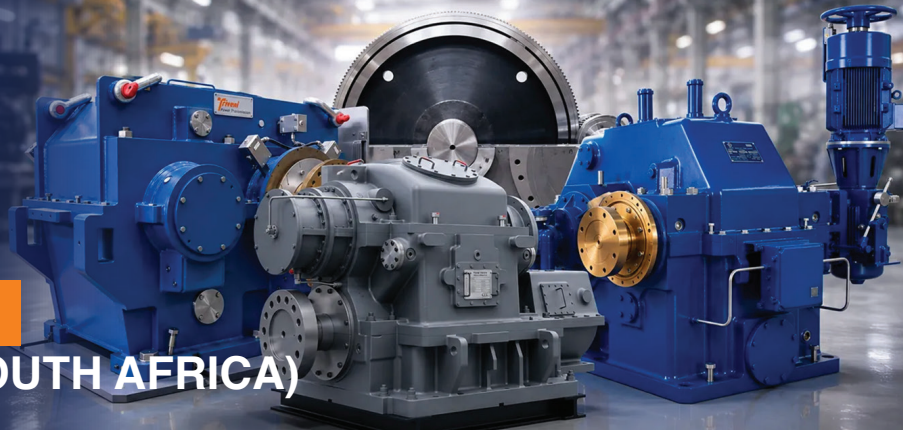
- Severe pitting on gear teeth, indicating progressive surface fatigue
- Gear components had significantly degraded due to repeated failures
- Bearing clearances were found to be beyond permissible limits
- Critical components including planet gears, annulus ring, and planet pin journals were damaged
- Reverse engineering was not feasible due to the poor condition of the existing parts

- The primary root cause was identified as uneven load distribution across bearings, leading to end loading of gears
- This resulted in localized stress concentrations and initiation of pitting damage
- Repeated operation under deteriorated conditions accelerated progressive gear and bearing failure, ultimately leading to system breakdown

- Designed and manufactured new sun pinion and planet gears, compatible with the existing system configuration
- Supplied a complete set of new gear internals, including annulus ring, planet gears, sun pinion, and planet pins
- Installed new bearings to ensure proper load distribution and operational stability
- Assembled the gearbox and conducted a full-speed, no-load trial run as per standard procedures
