## GAS TURBINE – GENERATOR GEARBOX (IPP INDIA – GUJARAT)

### 2 PREAMBLE / PROBLEM REPORTED

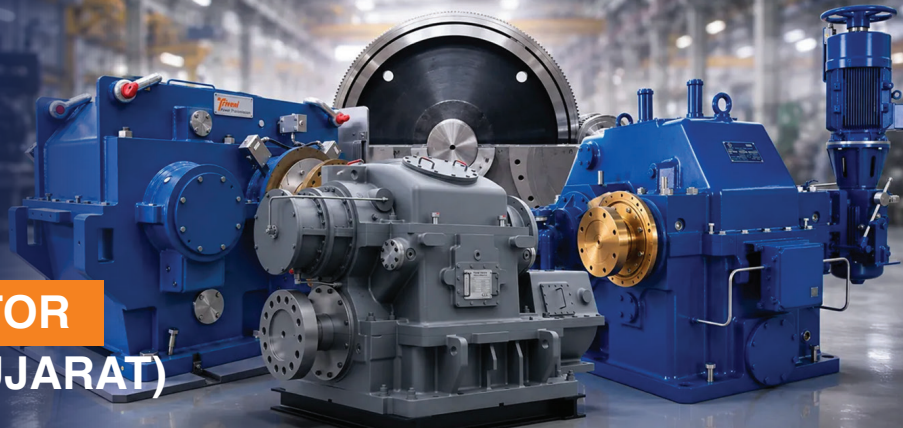
Repeated failures of the pinion shaft teeth were reported in Unit 3 of the gas turbine generator gearbox. The failures were consistently observed near the apex region of the pinion teeth, accompanied by an abnormal rise in pinion bearing temperature, indicating a systemic issue affecting gearbox reliability.

- Multiple instances of identical tooth failures near the apex region of the pinion.
- No deficiencies observed in gear strength or service factor.
- All operating parameters, including vibration and load conditions, were within acceptable limits.
- Detailed study of lubrication behaviour indicated localized overheating across gear teeth.
- Significant temperature variation across the face width resulted in uneven thermal expansion, leading to localized loading.

- The root cause was identified as improper heat dissipation across the gear teeth, driven by an unsuitable helix configuration
- The existing helix orientation caused heat concentration at the leading edge, resulting in thermal stress buildup.
- This led to localized overloading and recurring tooth failures in the pinion
