## STEAM TURBINE GEARBOX (IPP– PHILIPPINES)

### 2 PREAMBLE / PROBLEM REPORTED

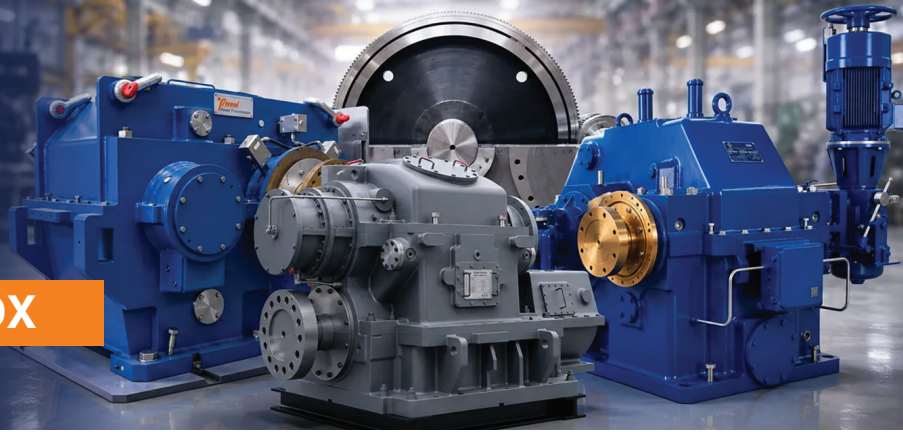
Tooth Failure noticed on both in pinion and gear tooth

The identical failure pattern confirmed a systematic design limitation

- Tooth uprooting indicated insufficient load-carrying capacity under operating conditions
- The gearbox was operating with a service factor of 1.1, significantly below recommended industry standards
- The system was exposed to transient loads due to grid disturbances and short-circuit conditions, which were not adequately accounted for in the original design
- These transient conditions led to localized overloading and repeated gear failures
- This led to localized overloading and recurring tooth failures in the pinion

- Designed a new gearbox with an increased service factor of 1.4, aligned with international standards
- Gear module increased to improve tooth strength and fatigue resistance
- Introduced pressure dam bearings to improve performance under no-load and partial-load conditions and to suppress sub-synchronous vibrations during transient events
