## STEAM TURBINE PLANETARY GEARBOX (IPP – SOUTH INDIA)

### 2 PREAMBLE / PROBLEM REPORTED

Gear failure was reported in the steam turbine generator (STG) planetary gearbox at an IPP unit in South India. The failure resulted in repeated shutdowns and reduced reliability of the generating unit.

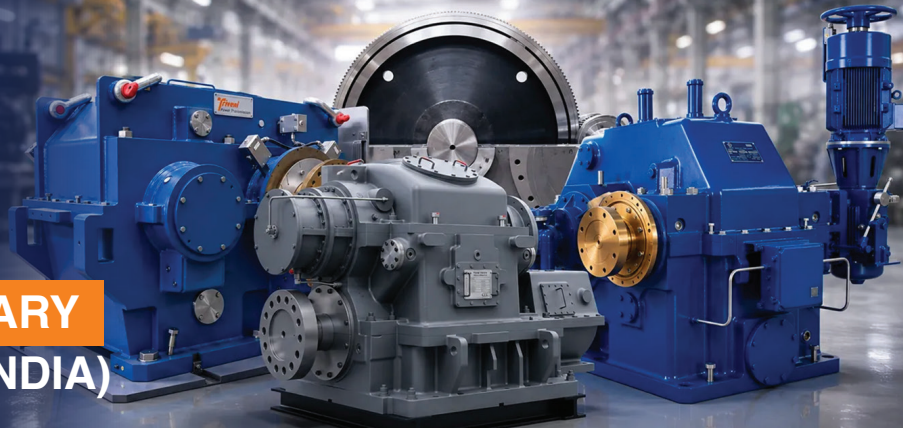
- Pitting observed on sun and planet gears, indicating progressive surface damage
- All bearings were found damaged, requiring replacement
- Maintenance history confirmed recurring gear failures despite prior corrective actions

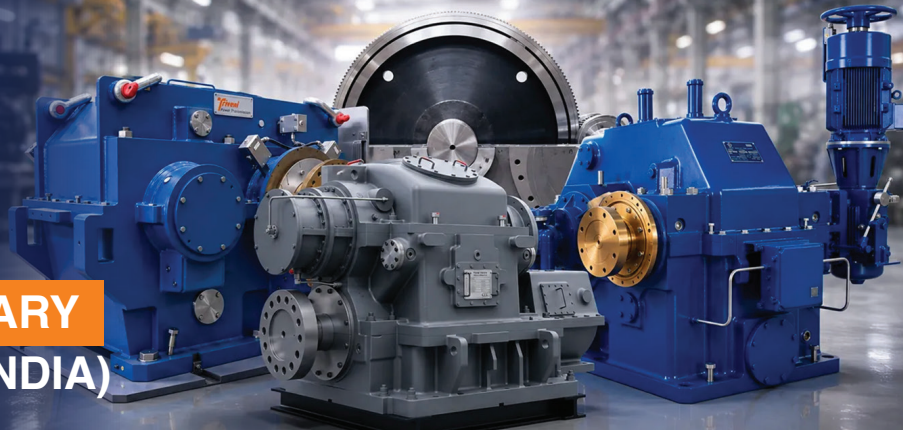
- The root cause was identified as pin bearing failure due to oil flow blockage.
- Restricted lubrication led to inadequate oil supply, causing localized wear and pitting of gear teeth.
- Subsequent bearing degradation further aggravated gear damage, resulting in repeated failures.

- Designed and manufactured new sun pinion and planet gears compatible with the existing ring gear, in line with Triveni design standards. The oil supply line size was increased to pin bearing to ensure required oil flow through bearing.
- Reassembled the gearbox using new bearings supplied by the customer
- Ensured proper blue contact across both helices of sun and planet gears to achieve uniform load distribution
